# TEST REPORT

No.: E190729004-02

**Applicant** : Shenzhen Signal Electronics Co.,Ltd

| Sample No. | Sample name | Model | Quantity |
|---|---|---|---|
| E19072900401 | M5 Molding Line Series (male and female) +M5 Panel Series (male and female) | 050004-03-002<br>050004-04-002<br>050004-05-001<br>050004-06-001 | 1 pc |

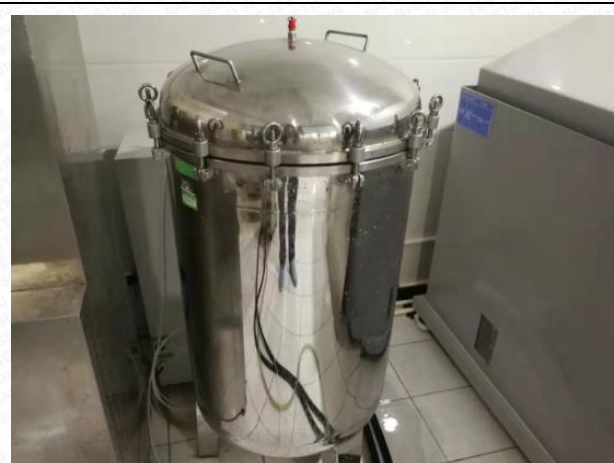
Fig.10 IPX8 test

| Test Item | Test Type | Test Conditions |
|---|---|---|
| IPX8 | Tests for protection against water | Water-level on enclosure: 2 m above bottom<br>Duration of test: 1 h |

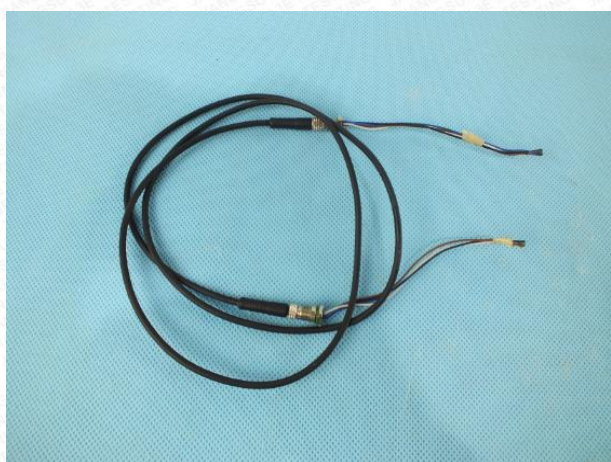
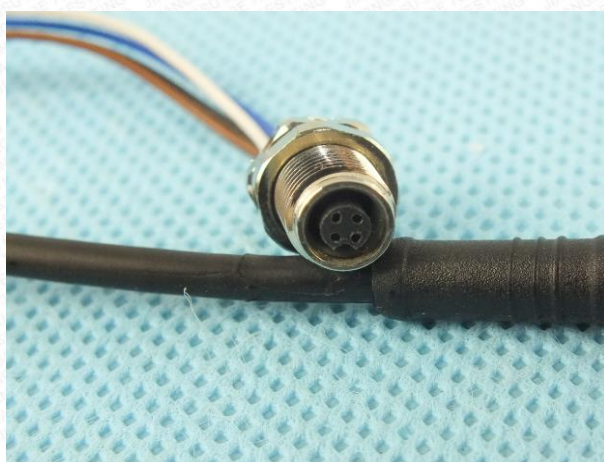
Fig.11 Sample photo after the test(1#)

Fig.12 Sample photo after the test(1#)

| Sample No. | Test Type | Test Result | Technical Requirement | Conclusion |
|---|---|---|---|---|
| E19072900401 | Tests for protection against water | No ingress of water | Allow water has entered, it shall not be sufficient to interfere with the correct operation of the equipment or impair safety | Pass |

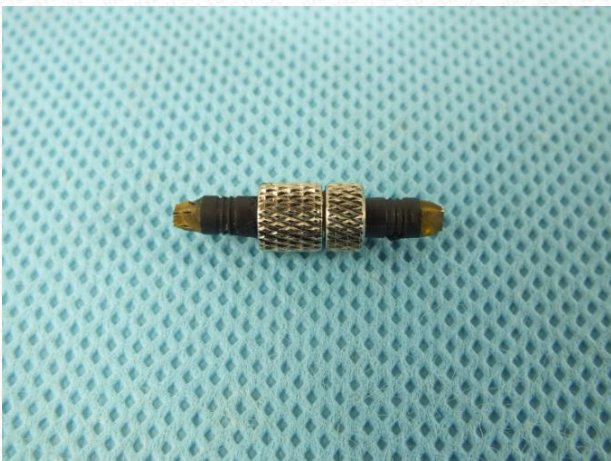
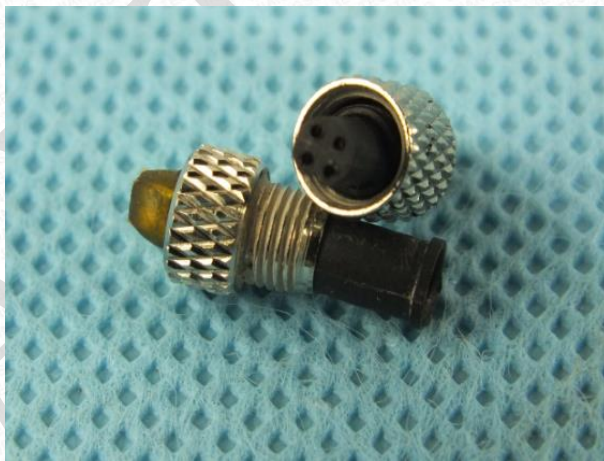
Fig.13 Sample photo after the test(2#)

Fig.14 Sample photo after the test(2#)

| Sample No. | Test Type | Test Result | Technical Requirement | Conclusion |
|---|---|---|---|---|
| E19072900402 | Tests for protection against water | No ingress of water | Allow water has entered, it shall not be sufficient to interfere with the correct operation of the equipment or impair safety | Pass |

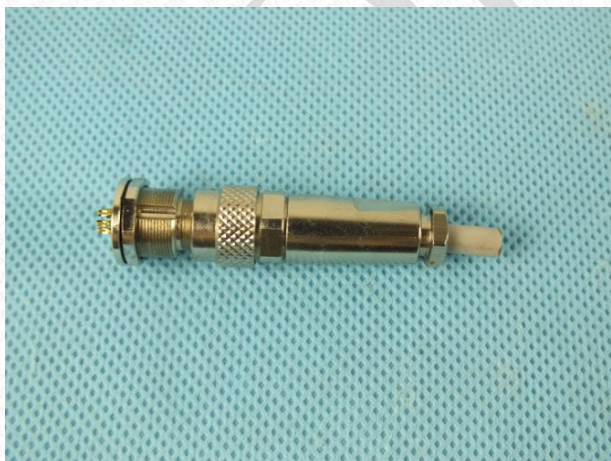
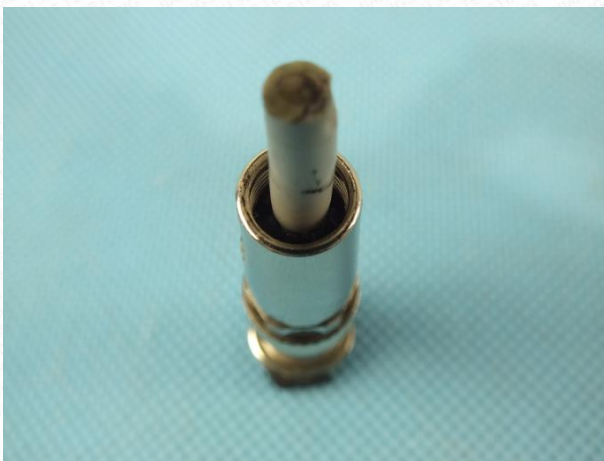
Fig.15 Sample photo after the test(3#)

Fig.16 Sample photo after the test(3#)

| Sample No. | Test Type | Test Result | Technical Requirement | Conclusion |
|---|---|---|---|---|
| E19072900403 | Tests for protection against water | No ingress of water | Allow water has entered, it shall not be sufficient to interfere with the correct operation of the equipment or impair safety | Pass |

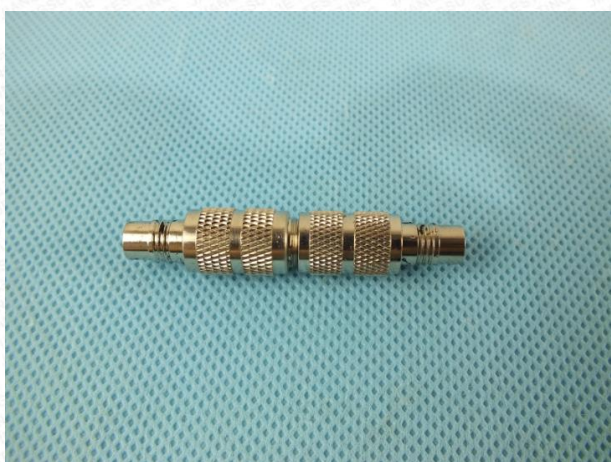
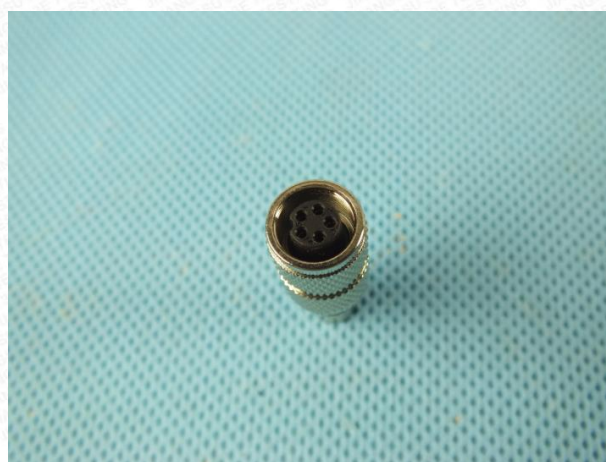
Fig.17 Sample photo after the test(4#)

Fig.18 Sample photo after the test(4#)

| Sample No. | Test Type | Test Result | Technical Requirement | Conclusion |
|---|---|---|---|---|
| E19072900404 | Tests for protection against water | No ingress of water | Allow water has entered, it shall not be sufficient to interfere with the correct operation of the equipment or impair safety | Pass |

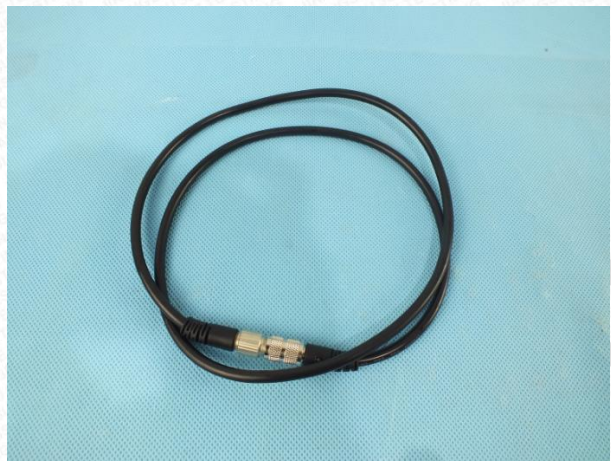
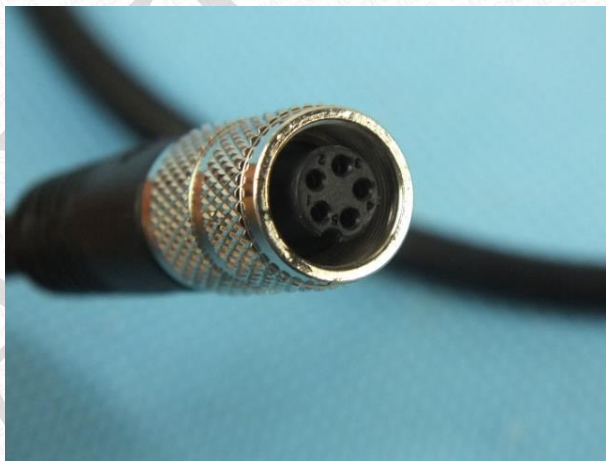
Fig.19 Sample photo after the test(5#)

Fig.20 Sample photo after the test(5#)

| Sample No. | Test Type | Test Result | Technical Requirement | Conclusion |
|---|---|---|---|---|
| E19072900405 | Tests for protection against water | No ingress of water | Allow water has entered, it shall not be sufficient to interfere with the correct operation of the equipment or impair safety | Pass |

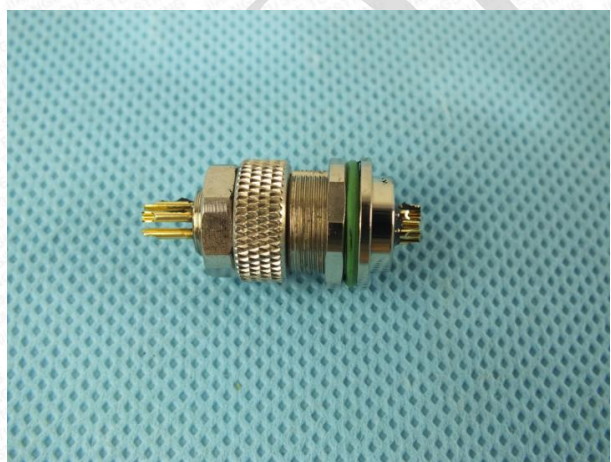
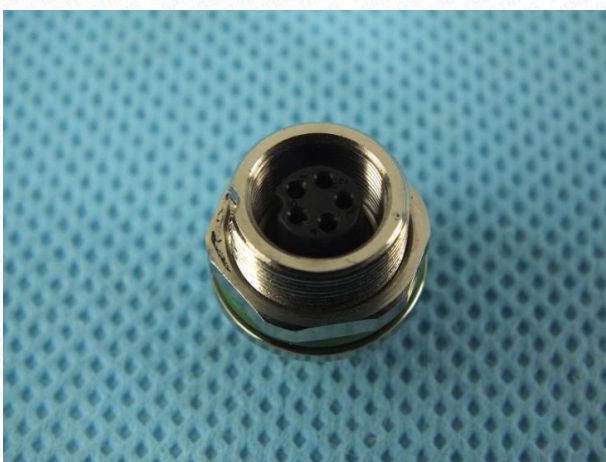
Fig.21 Sample photo after the test(6#)

Fig.22 Sample photo after the test(6#)

| Sample No. | Test Type | Test Result | Technical Requirement | Conclusion |
|---|---|---|---|---|
| E19072900406 | Tests for protection against water | No ingress of water | Allow water has entered, it shall not be sufficient to interfere with the correct operation of the equipment or impair safety | Pass |

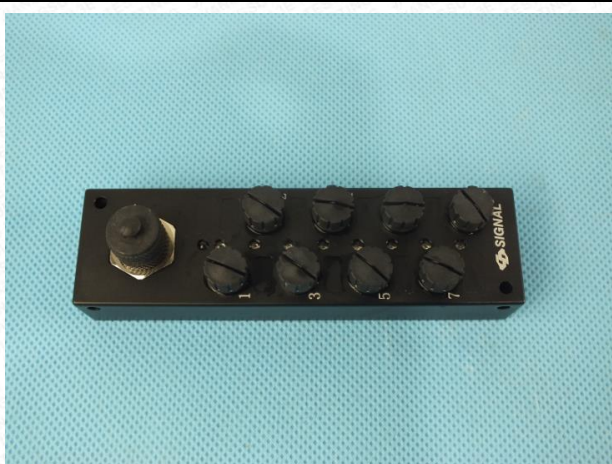
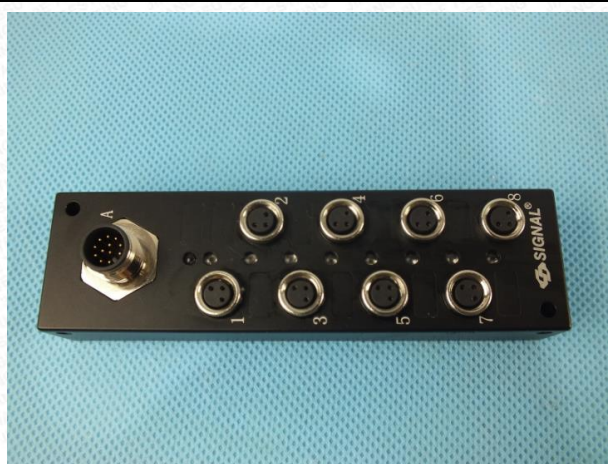
Fig.23 Sample photo after the test(7#)

Fig.24 Sample photo after the test(7#)

| Sample No. | Test Type | Test Result | Technical Requirement | Conclusion |
|---|---|---|---|---|
| E19072900407 | Tests for protection against water | No ingress of water | Allow water has entered, it shall not be sufficient to interfere with the correct operation of the equipment or impair safety | Pass |

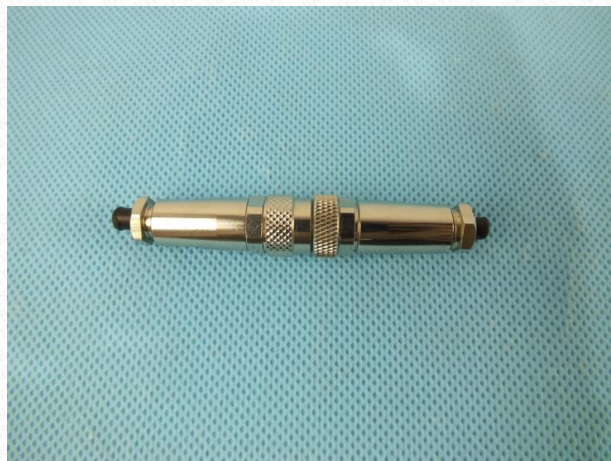
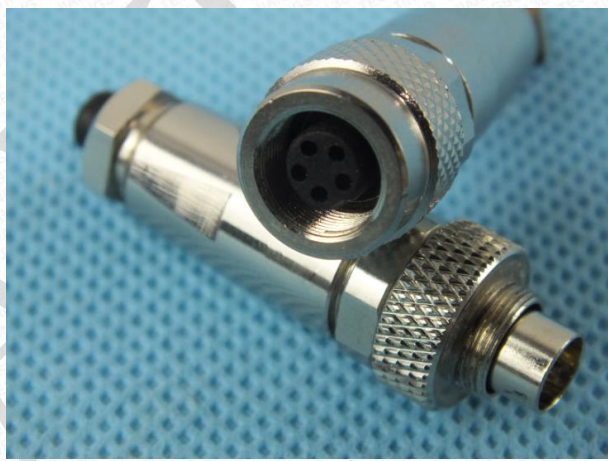
Fig.25 Sample photo after the test(8#)

Fig.26 Sample photo after the test(8#)

| Sample No. | Test Type | Test Result | Technical Requirement | Conclusion |
|---|---|---|---|---|
| E19072900408 | Tests for protection against water | No ingress of water | Allow water has entered, it shall not be sufficient to | Pass |

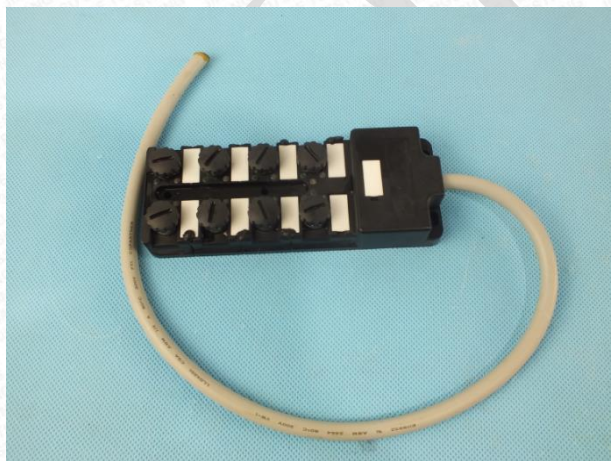
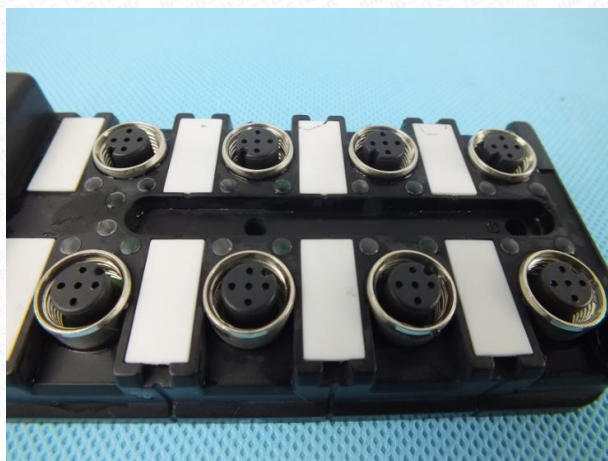
Fig.27 Sample photo after the test(9#)

Fig.28 Sample photo after the test(9#)

| E19072900409 | Tests for protection against water | No ingress of water | Allow water has entered, it shall not be sufficient to interfere with the correct operation of the equipment or impair safety | Pass |
